## Research study on the Sinking Sequence of MV Estonia

Dr. Claes Källström, Vice President, SSPA Sweden

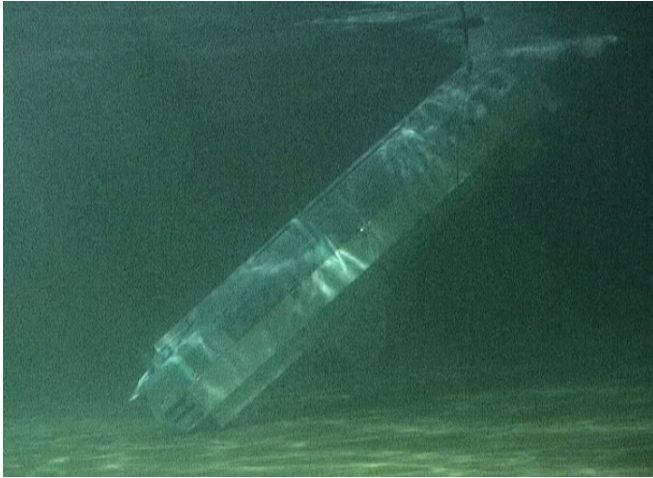
*Model test with MV Estonia in SSPA's MDL. After capsizing, the ship sank with the aft part of the ship hitting the seabed first.*
